National Aeronautics and  
Space Administration

October 5, 1982

Your question regarding the Voyager CRS performance, the following observations will help characterize the CRS problem for you. As you know, the problem affects Block I only, and is evident by the appearance of a well defined 45° line in those two-dimensional PHA distributions involving PHA 2. This line is 4 or 5 channels wide and has intercept at about channel 10. The normal particle lines appear to be transposed onto the 45° line wherever the nominal distribution would lie below the diagonal line. All rates, including those associated with the PHA events, are normal; the PHA distributions for all three telescopes associated with Block I are distorted. As you recall each of the three PHA's (PHA 1, PHA 2, and PHA 3) analyze pulses from one of several detectors, depending on event type. The malfunction is limited to PHA 2, and appears to force that parameter to exhibit a channel number that is 10 channels greater than the larger of either PHA 1 or PHA 3. The attached block diagram which is greatly simplified, depicts the relevant portions of the system.

Simplified Voyager PMA Block Diagram

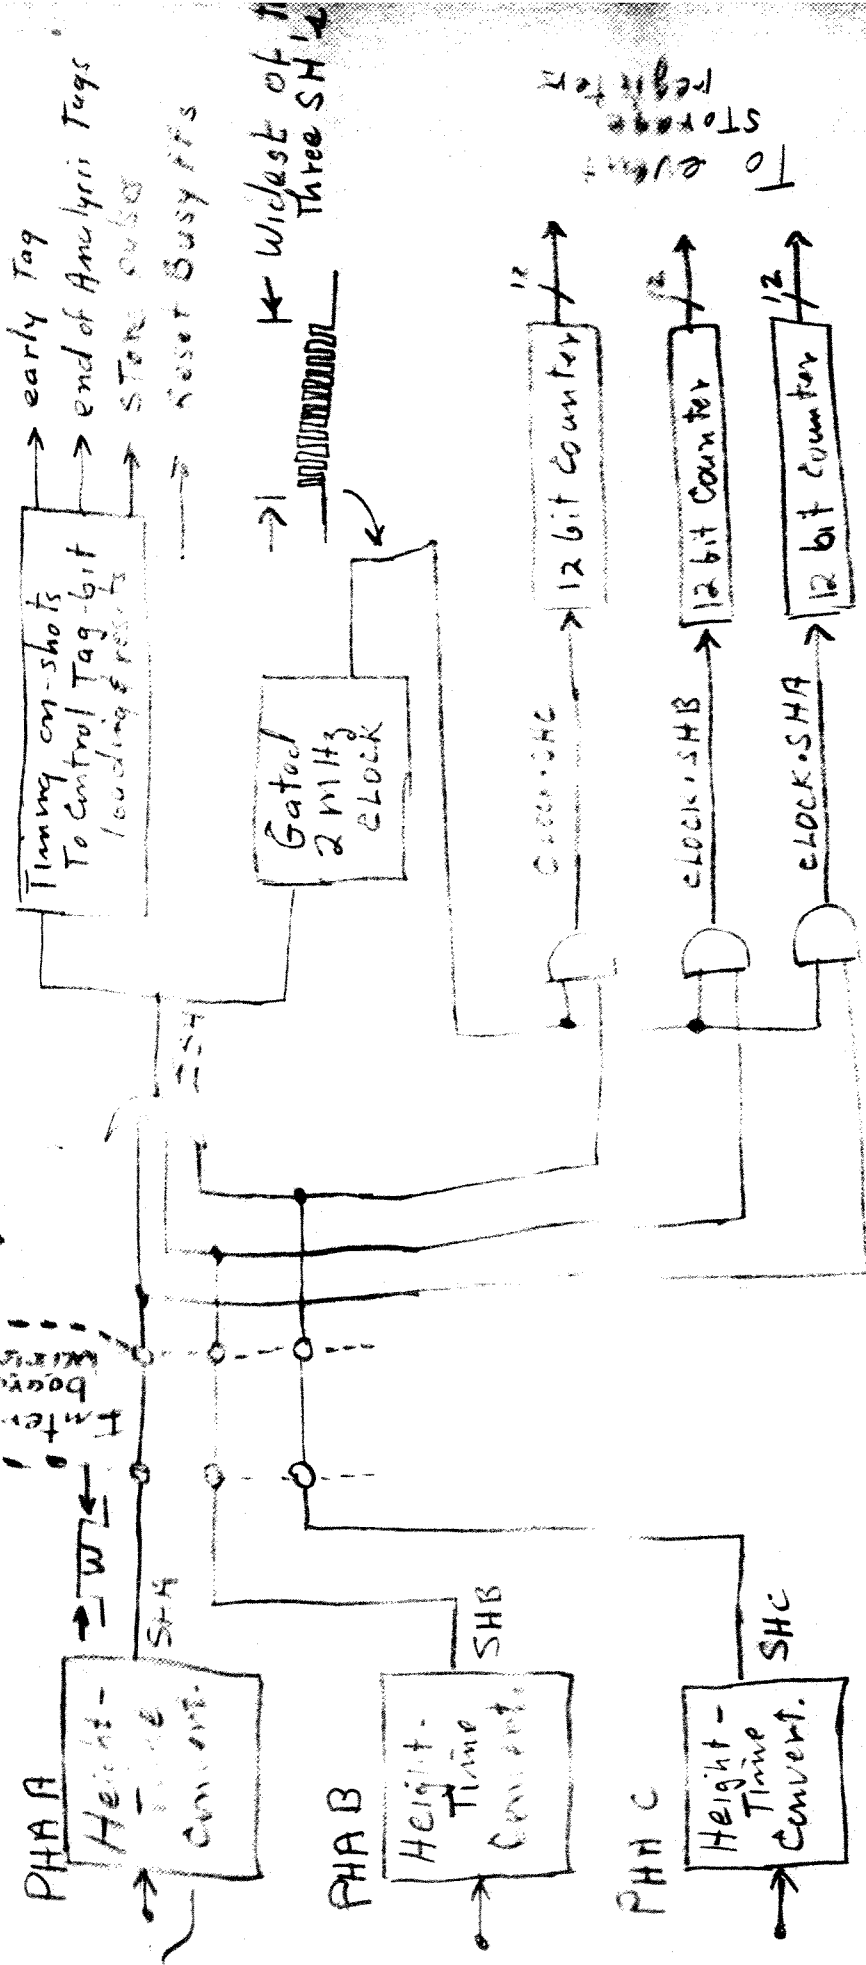
Fig 1

There are three ways in which PHA 2 could conceivably take on a value of the larger of PHA 1 or 3, but none of these immediately and obviously explain why an additional 10 channels are added. The three explanations (see attached figure) are:

1. An open circuit in the SHB signal between the analog board and the digital board.
2. A shorted transistor in the "OR" gate (Q2) which allows the OR of SHA and SHC to overpower the SHB signal.
3. A malfunction in the COSMOS gate prior to the address counter.

There could well be other mechanisms that would produce the same result. Item 3 above is probably the most unlikely. Either 1 or 2 are plausible kinds of failures, but the exact effect of either is difficult to predict without bread-boarding portions of the circuitry, particularly with regard to the 10-channel add-on feature.

We are in the process of locating parts to complete a mini-breadboard, and will keep you informed of the results.
